POWER ENGINEERING CORPORATION

Issue

Internal damage to dredge pumps reduced MTBR to <6 months, causing delays to harbour dredging project and forcing client to consider upgrading to higher alloy pumps.

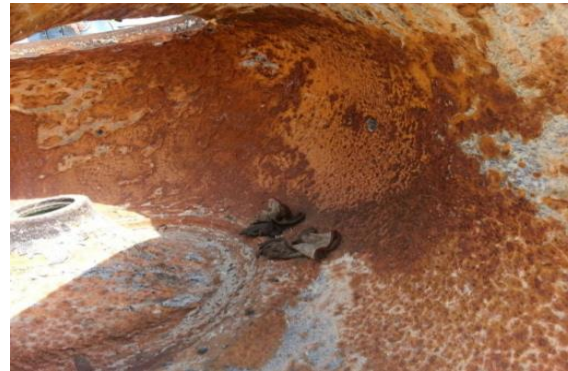
Combination of high chlorides and abrasive slurry passing accelerated erosive attack to as much as 12 mm in <6 months

Worn pump **before** application of ARC BX1 and ARC S2

1. Decontaminate surfaces
2. Grit blast to Sa 2.5 with 3 mil (75 µm) angular profile

1. Rebuild zones of high wear with ARC BX1 @ 240 mils (6 mm) minimal thickness
2. Apply two alternating colour topcoats of ARC S2 to all surfaces @ total DFT of 20 mils (500 µm)

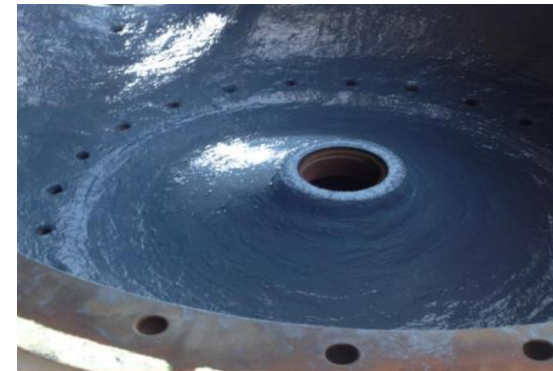
After application of ARC BX1 and ARC S2

1. Repairs accomplished within 48 hours
2. After 6 months the repaired pumps continue to operate
3. Expected ARC coating repair cycle is 10-12 months – increasing MTBR by 3X
