COMPOSITE REPAIR FOR SUBSEA PIPE REINFORCEMENT

PROJECT NAME **48 INCH OFFSHORE PIPELINE COMPOSITE REPAIR**
 PIPE DETAILS **48" oil line – max. op. temp. 35°C – op. pressure 18.2 bars**
 LOCATION **QATAR – Halul Terminal**
 3X / PEC SOLUTION **REINFORCEKIT® 4D SUBSEA (R4D-S)**

The objective of the repair, performed in April 2020 by **ALQODARA ALHANDASEYA (PEC)** and his partner **3X ENGINEERING Monaco (3X)**, was to **reinforce a 48" subsea pipe damaged by 2 dents**.

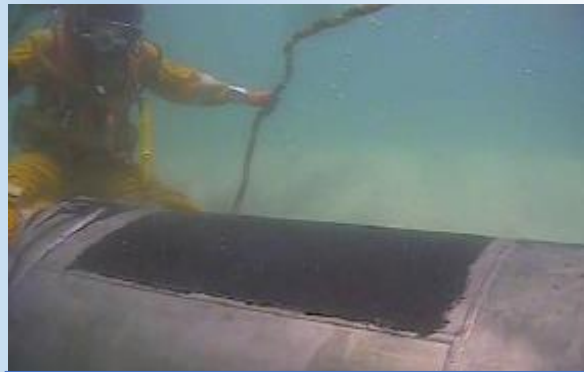
Figure 1: P3X30 primer application on defected area (step 2)

According to ISO 24.817 and 3X repair calculations, 32 layers of R4D-S have been determined to reinforce the damaged pipe section (dent No. 1 measured 840mm x 445mm and dent No. 2 measured 770mm x 482mm).

- ② **P3X30 primer** application right on the defect to ensure a good bonding of the composite plate (step 3).
- ③ **F3XSS filler** application on rigid composite plate. The plate was then given to the diver and positioned over the dent and fastened tightly with ratchet belts (previously installed – see step 1).

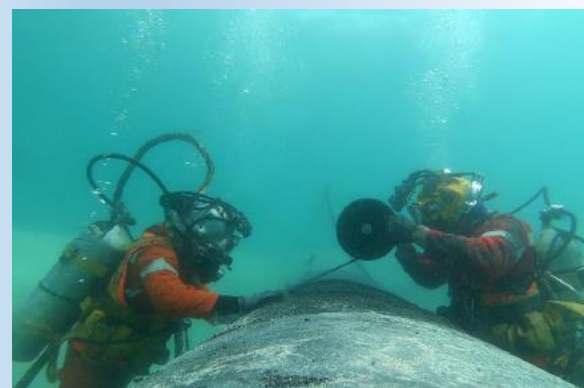
Figure 3: Composite wrapping on progress (step 5)

- ⑤ Kevlar® tape impregnated with **R3X1050S resin** and wrapped around the pipe. The tape impregnation is performed using BOBIPREG (3X specific machine allowing a quick and regular impregnation resin/fiber). Thirty-two layers were necessary to repair the defect (i.e. 16 passes of 50% overlap) for a total of 3m repair length.

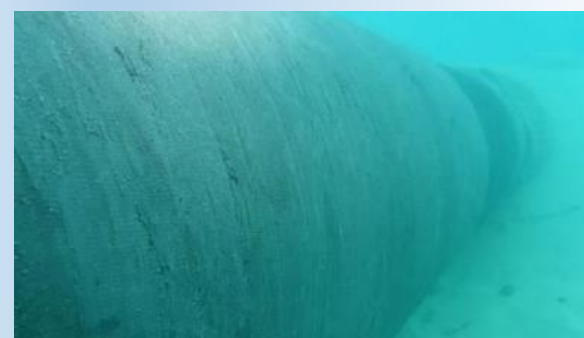
Figure 4: Repair overview

- ⑥ Finalization of the repair with reference plate positioning for traceability purpose and validation of the repair using hardness measurements.

The subsea reinforcement was successfully repaired using **REINFORCEKIT® 4D SUBSEA** product. This project was a great challenge due to the large diameter of the line and the shallow water position of the defects. Meantime, all the teams involved in the project faced with the international COVID-19 pandemic, with all the constraints and associated challenges (manpower, shipment of the material, quarantine time, etc.)
