## Protection of Hydrochloric Acid Pit using ARC 791

Client: QVC

Location: Qatar

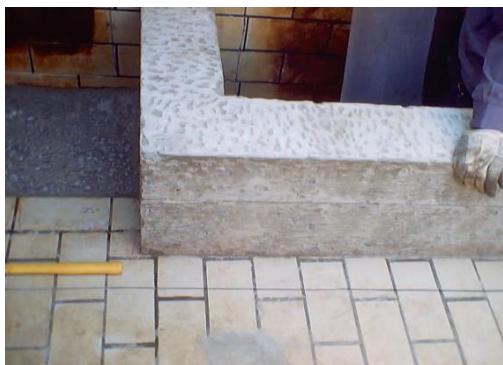
Corrosion in Concrete wall For Hydrochloric Pit.

Wall after surface Preparation and decontamination

- Remove all contaminants and acid residues using Chesterton 803 cleaner.
- Surface preparation was held.

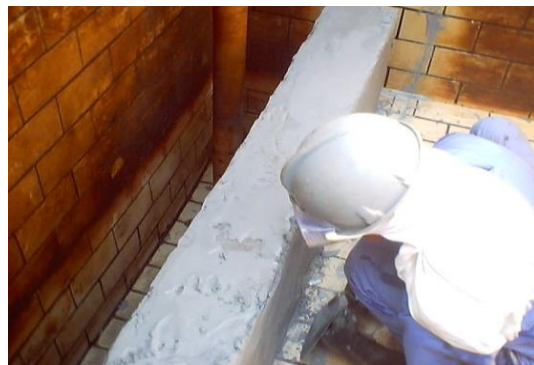
Applying of ARC 791 by Chesterton specialist

- Prime Using ARC 797.
- Top Coat by ARC 791 using steel trowel with 6mm DFT.

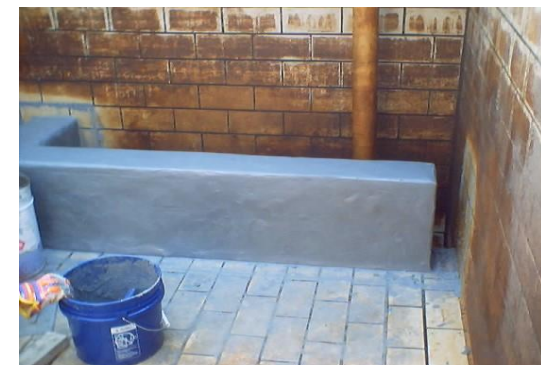
ARC 791 is more effective compared to anti-acid ceramic tiles

- The pit returned to service in less than 6 hours.
- Client reported that ARC Coatings is much more efficient and cost effective when compared to anti-acid ceramic tiles.
- So far, and after 10 years of application of ARC 791 the pit is working without any issues.
