## CMS 2000 Installation for Cooling Pump

**Client:** QVC

**Location:** Mesaieed, Qatar

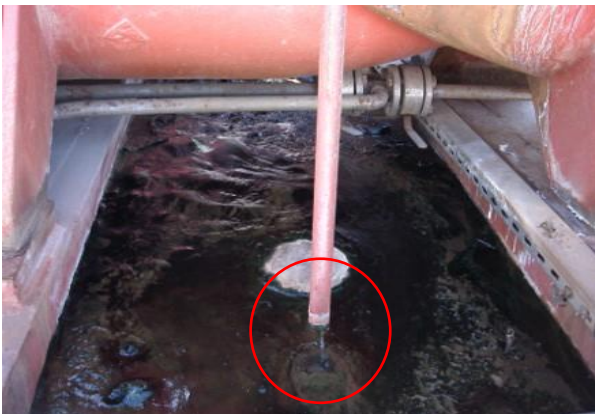
1. Gland packing leakage at cooling pump.
2. Client changes packing every 6 months.

Pump leakage before installing CMS-2000

1. One ring of 412-w packing ring was insert into stuffing box using CHESTERTON tamping tool.
2. Fill stuffing box with CMS-2000.
3. Install outer packing ring (412-w).
4. Start pump and tighten to control leakage.

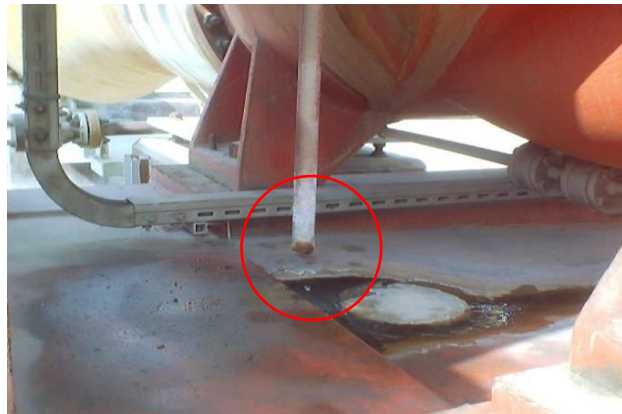
Pump leakage after installing CMS-2000

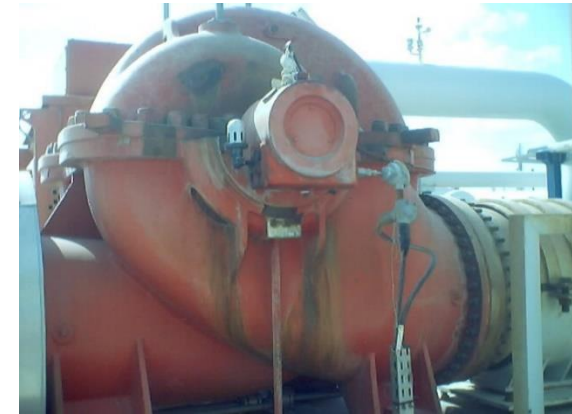
Pump in service after CMS -2000 installation by 18 months

1. Maintenance works was finished within half an hour.
2. Thanks to the very low coefficient of friction for CMS-2000, Cost savings was noticed as motor consumed power decreased as friction between pump shaft and the packing.
3. Energy saving 7000 hrs/year ,238000 kw
4. Increased the packing change interval up to 18 months.
5. Reduce shutdown intervals.
