# Rebuilding and protection of casing and back plate of Brine pump

POWER ENGINEERING CORPORATION

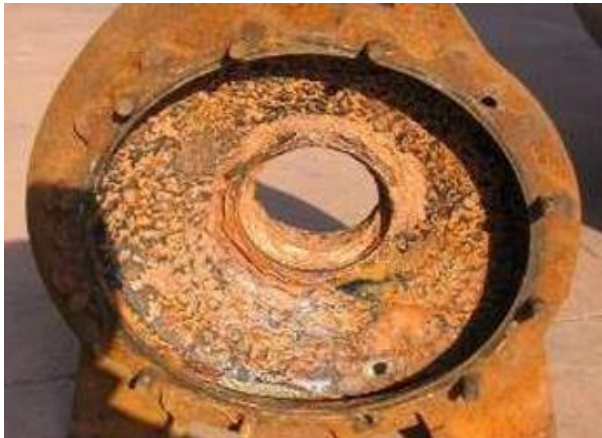
- Unprotected pump casings had a service life of <6 months.
- High levels of  $\text{FeO}^2$  in brine was causing contamination of membrane process.

Pump **before** applying ARC coating system

- Worn casings thoroughly decontaminated using steam cleaning with fresh water.
- Surfaces grit blasted to Sa2 ½ with 75+  $\mu$  profile

- ARC 858 used to fare corroded surfaces smooth and back to tolerance range.
- ARC 855 applied in two coats to provide corrosion resistance

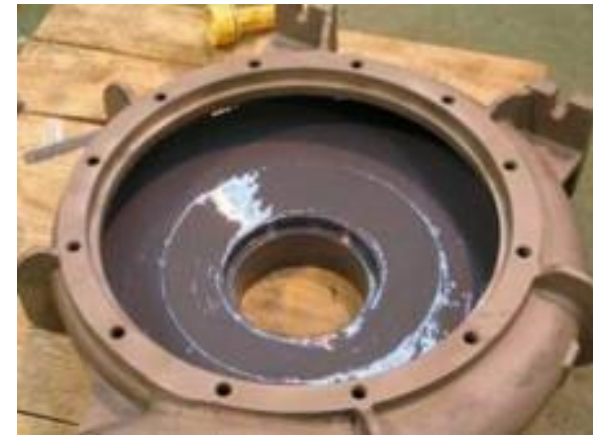
- Since pump coating program has been instituted the life of a pump has been extended from less than 6 months to more than 1.25 years.
- Brine production has been maintained with no further contamination due to trace  $\text{FeO}^2$

Pump **after** applying ARC coating system
